**FATIGUE BEHAVIOR OF A FUNCTIONALLY-GRADED TITANIUM MATRIX
COMPOSITE**

THESIS

Scott R. Cunningham, Captain, USAF

AFIT/GAE/ENY/05-M06

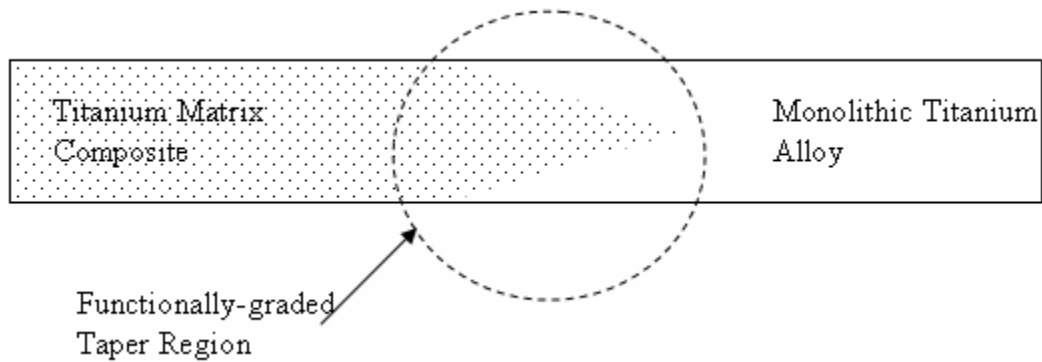
Figure 1: Functionally-graded, double scarf joint

This research investigates the mechanical behavior of a functionally-graded titanium matrix composite. The material is composed of a titanium matrix composite and a monolithic titanium alloy functionally-graded through the thickness (see Figure 1).

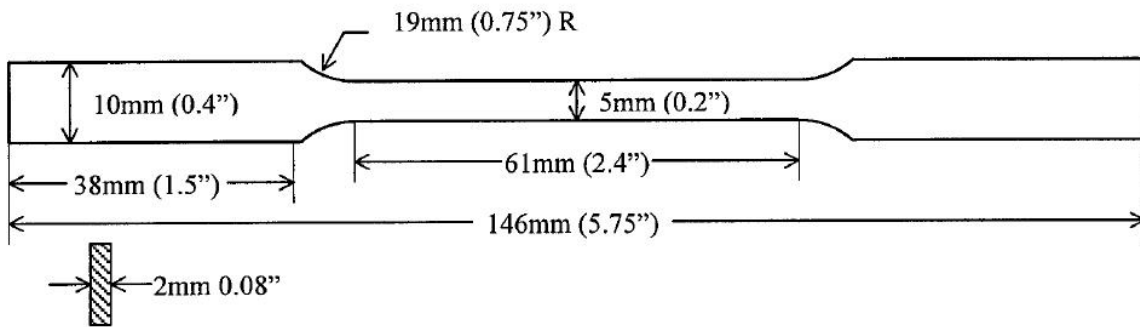
Figure 5: Dogbone specimen geometry

specimen was needed to ensure failure in the gage section during fatigue loading. By reducing the gage section's cross-sectional area, the localized stress is increased. However, in order to minimize stress raisers on the specimen edge, the shoulder radius must be as large as possible. This design loop resulted in the chosen geometry (see Figure 5). All specimens were cut from the plates by technicians of the AFIT Model Shop using Electrical-Discharge Machining (EDM) techniques.

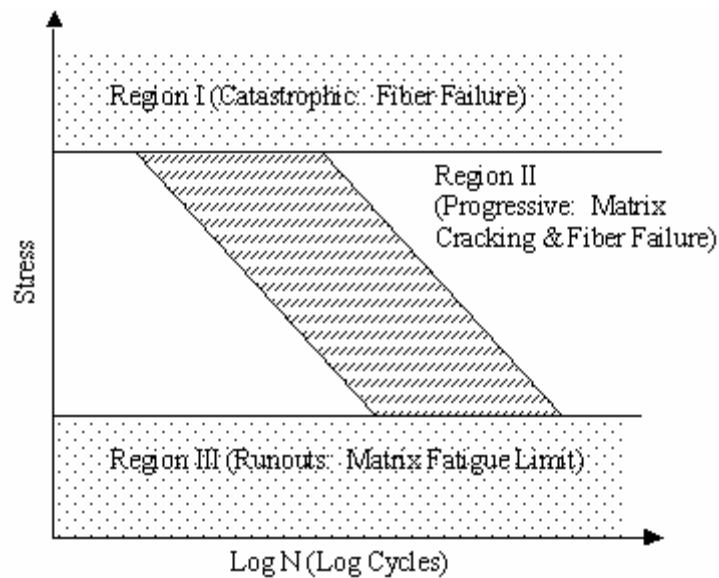
Figure 13: Typical S-N diagram

Many researchers have attempted to show the fatigue life diagram as three distinct regimes (Regime I, II and III) where each regime represents an area where certain failure mechanisms play dominant roles. Using Talreja's approach [21] for unidirectional composites, Region I failures correspond to overloading of the fibers resulting in fiber breakage and interfacial debonding. Damage in this region is characterized as catastrophic or non-progressive. Region II failures correspond to matrix, fiber and fiber/matrix interface cracking. Damage in this region is characterized as progressive. Region III corresponds to matrix cracking and the matrix fatigue limit. Damage in this region, if it occurs at all, is characterized as non-propagating or referred to as runout. A typical S-N diagram showing these regions is shown in Figure 13.

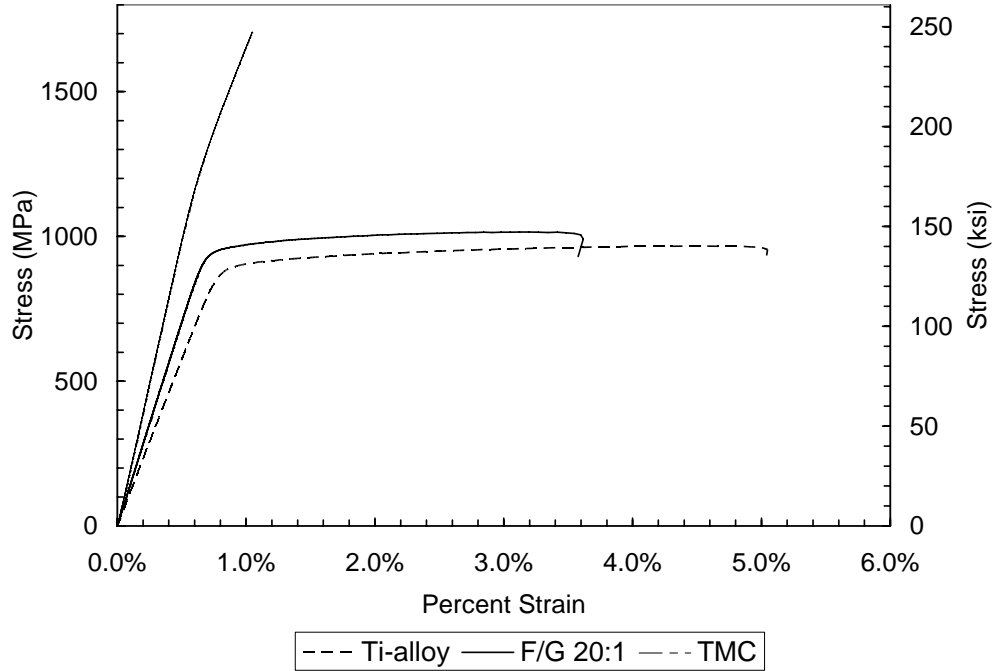
Figure 15: Tensile test results

The other measurement taken is the ultimate strength of the material. Just as its name implies, it is the highest stress value reached before failure occurs. The results from the extensometer and load measurements for the three materials are shown in Figure 15 and summarized in Table 1.

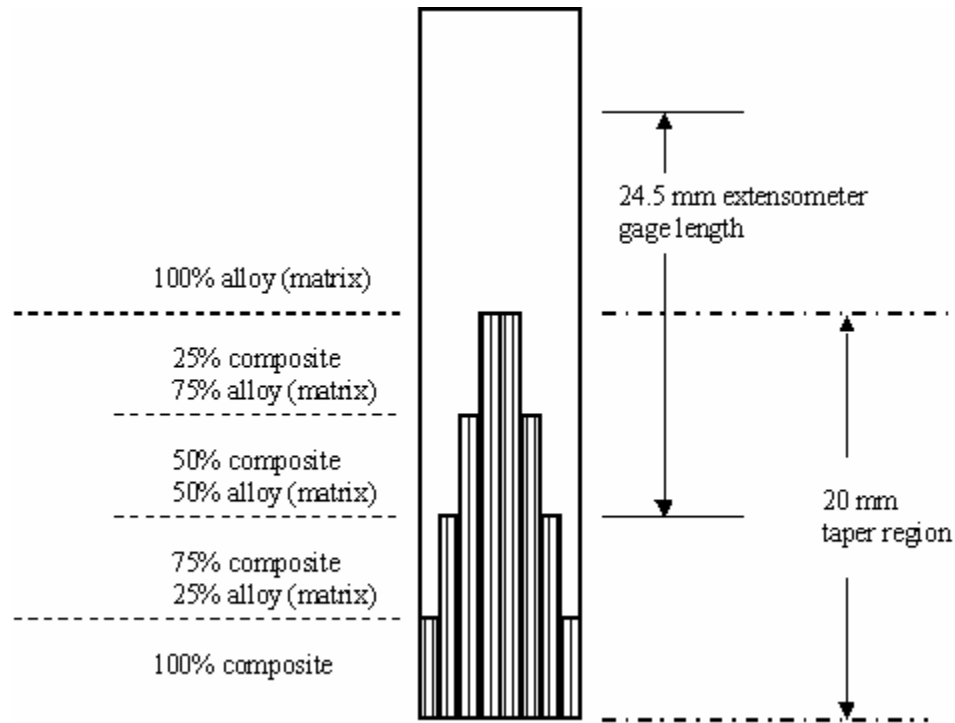
Figure 19: Taper section

19) where each step encompasses a different region with differing volume fractions of composite.

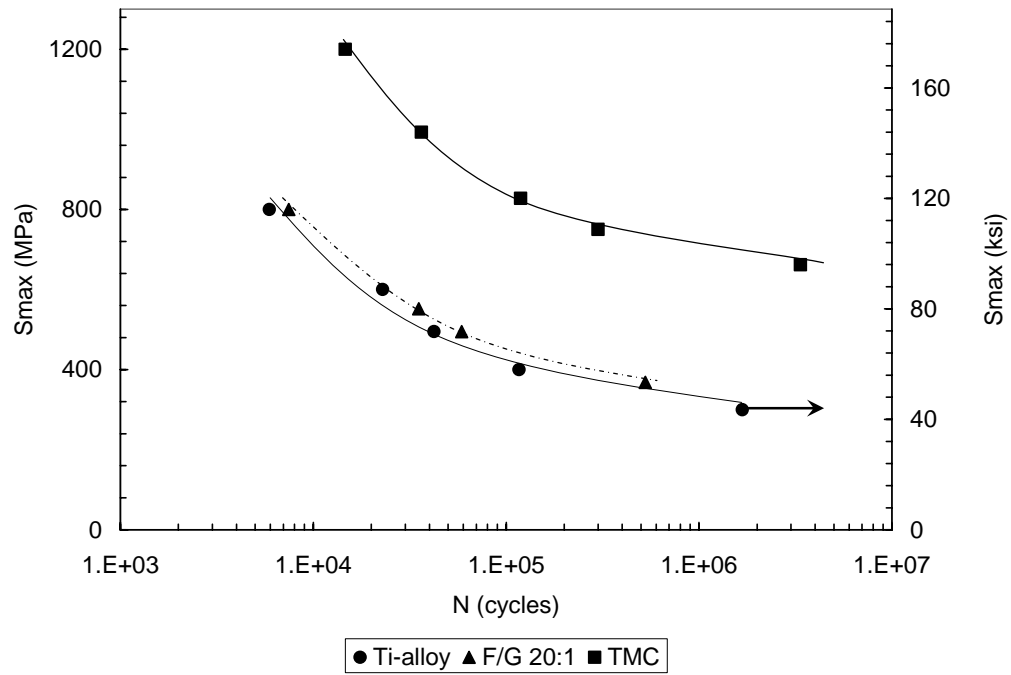
Figure 20: Tension-tension S-N curves

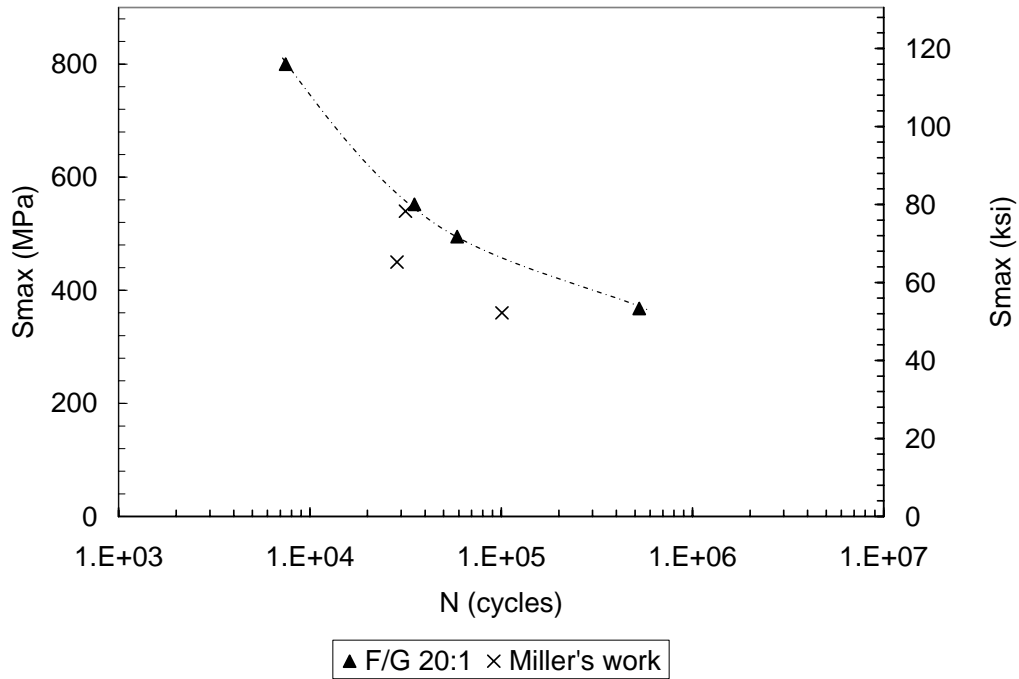
Figure 23: F/G TMC (20:1) comparison of tension-tension fatigue results

The results for the functionally-graded material under tension-tension fatigue showed higher fatigue lives when compared with Miller's data [15]. It should be noted that Miller also performed tests on a F/G TMC with a taper ratio of 4:1, however the present work is focused on the 20:1 taper ratio. A plot comparing Miller's results with the present work is shown in Figure 23.

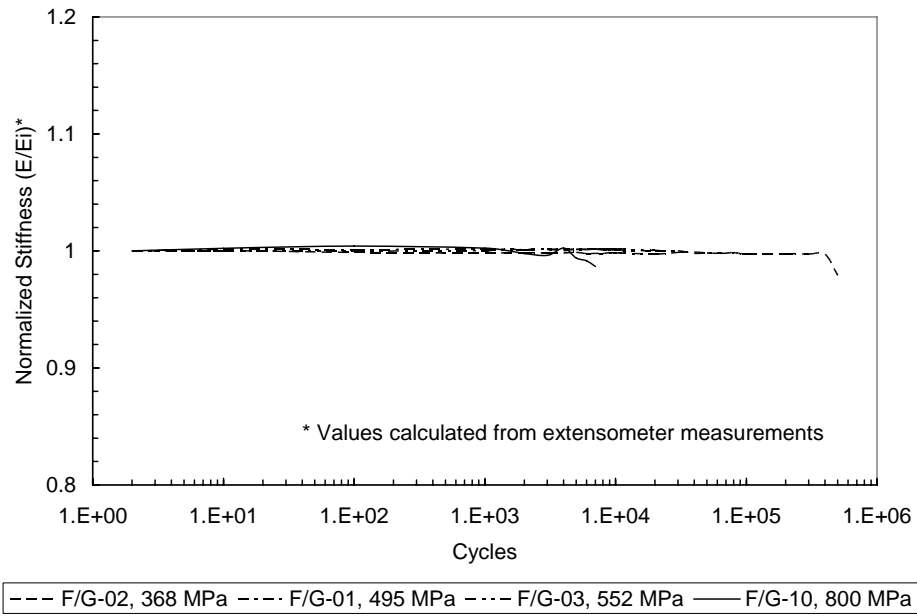
Figure 24: Tension-tension: normalized stiffness vs. fatigue cycles

material. Figure 24 and Figure 25 show plots of the normalized stiffness versus cycle number and normalized fatigue life, while Figure 26 and Figure 27 show plots of the percent strains versus cycle number and normalized fatigue life.

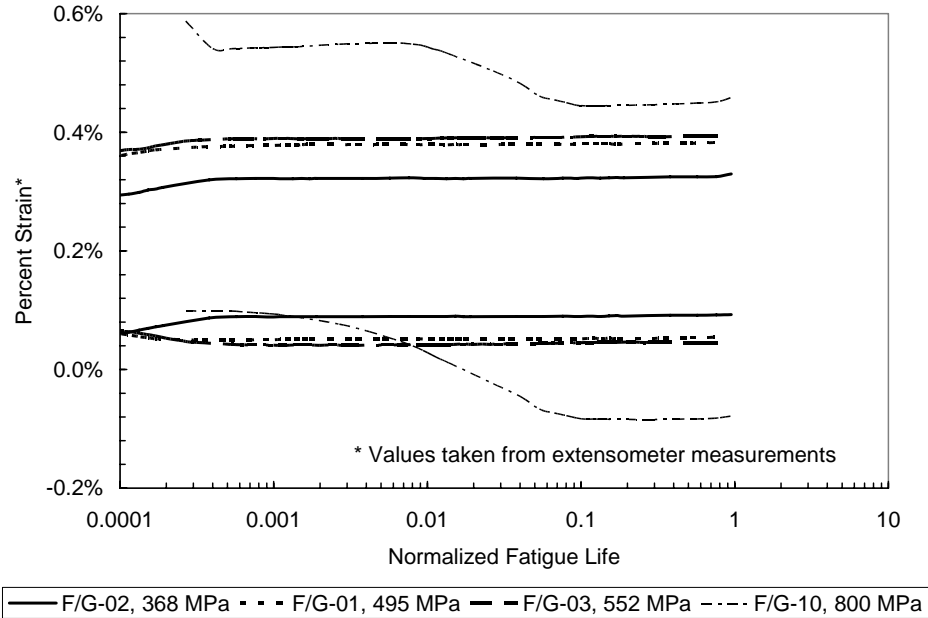
Figure 27: Tension-tension: max & min percent strain vs. normalized fatigue life

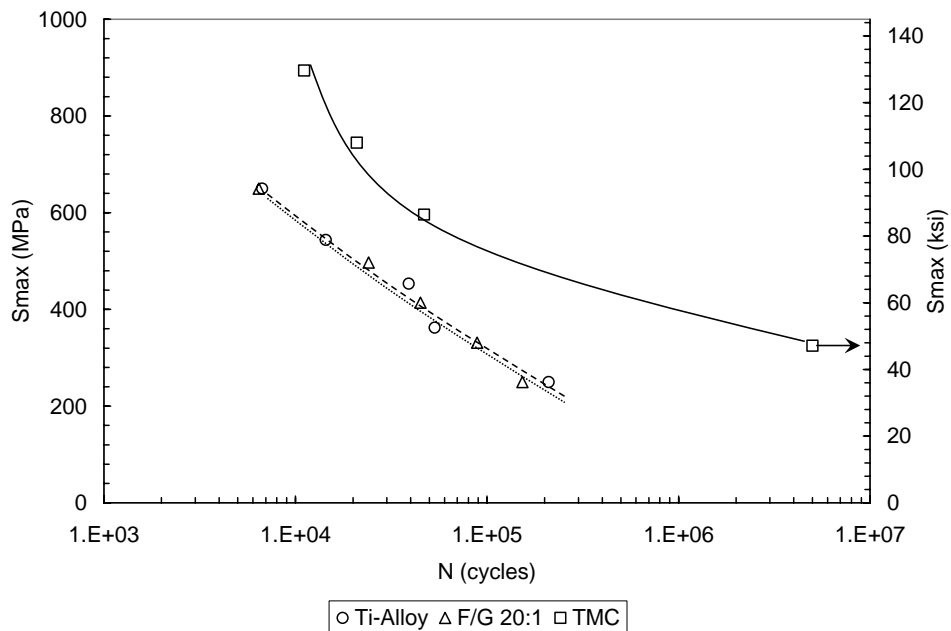
Figure 28: Tension-compression S-N curves

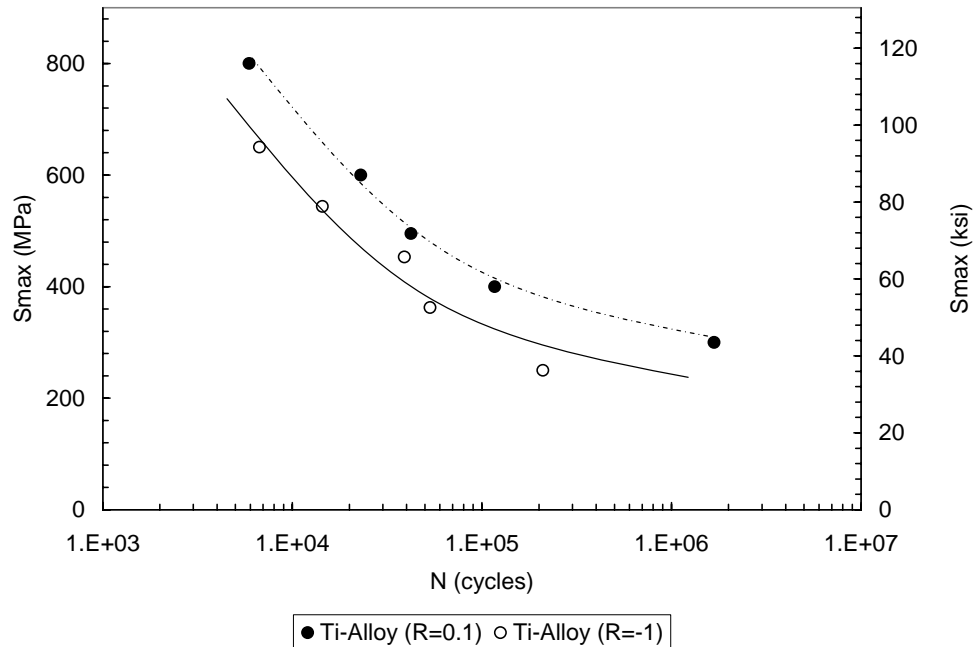
Figure 29: Titanium alloy TT and TC fatigue results (maximum stress comparison)

The fatigue life curve for the titanium alloy under tension-compression fatigue is shown in Figure 29. These results form the lower bound for the functionally-graded material under fully-reversed fatigue loading. As expected, when plotted on a maximum stress basis, the results show a shift in the fatigue life curve down and to the left when compared with the tension-tension results.

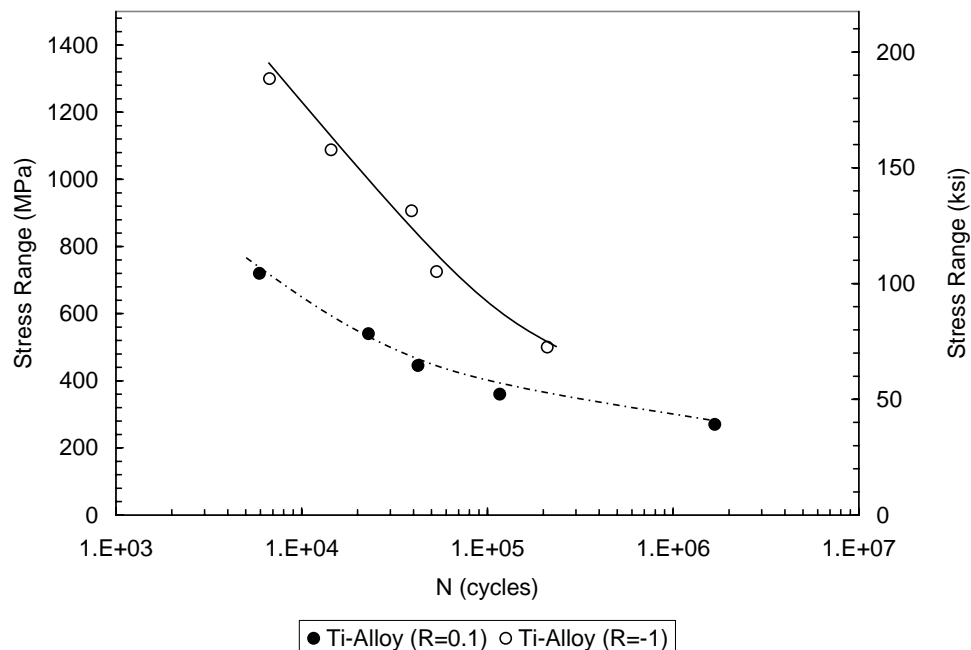
Figure 30: Titanium Alloy TT and TC fatigue results (stress range comparison)

However, when plotted on a stress range basis, a different phenomenon occurs (see Figure 30). The tension-compression fatigue lives are much longer than the tension-tension fatigue lives when plotted on a stress range basis. This would conclude that, while additional damage does occur during the compressive loading portion (representing half of the load range in the tension-compression case), it is not as detrimental to the fatigue life as a load range made up of tensile loads equal to twice the compressive range value.

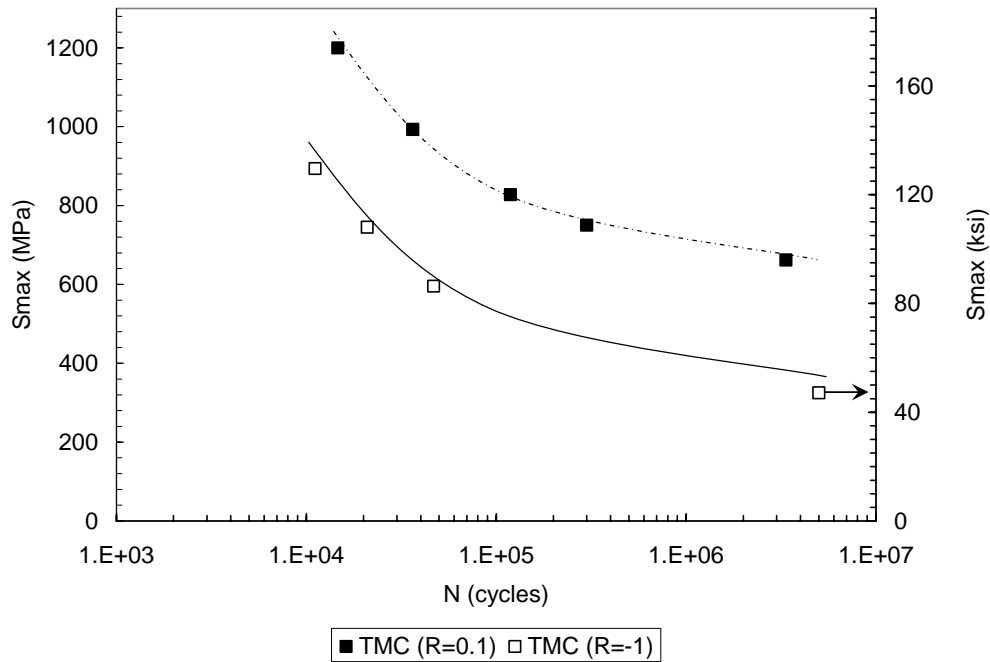
Figure 31: TMC TT and TC fatigue results (maximum stress comparison)

The fatigue life curve for the composite under tension-compression fatigue is compared to the results from the tension-tension case on a maximum stress basis in Figure 31. This data forms the upper bound for the functionally-graded material under fully-reversed fatigue loading.

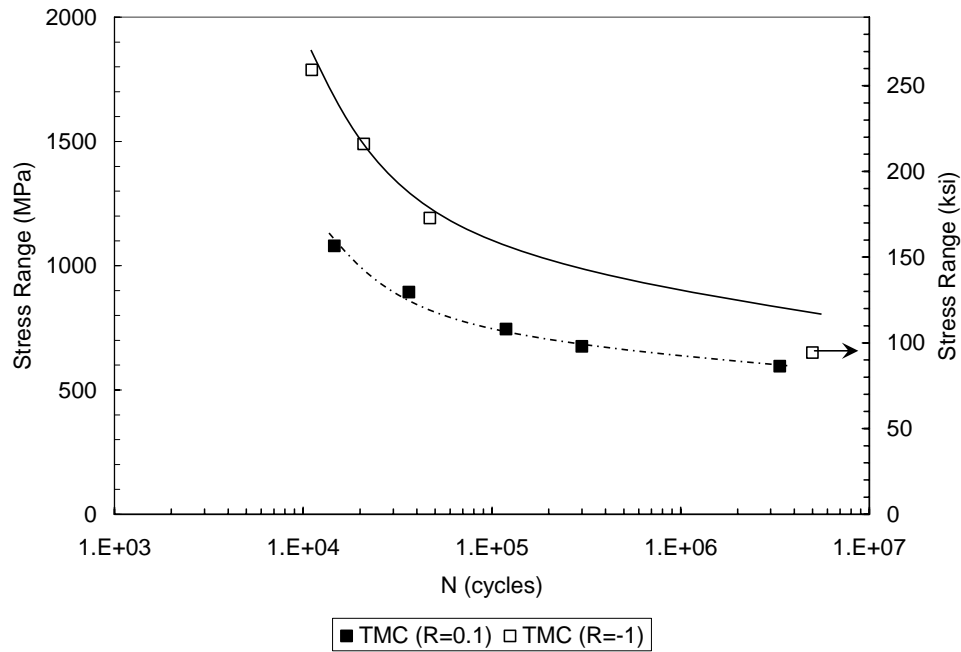
Figure 32: TMC TT and TC fatigue results (stress range comparison)

The fatigue lives for the tension-compression fatigue case are plotted on a stress range basis in Figure 32. As before, the tension-compression fatigue lives are much longer than the fatigue lives of the tension-tension case.

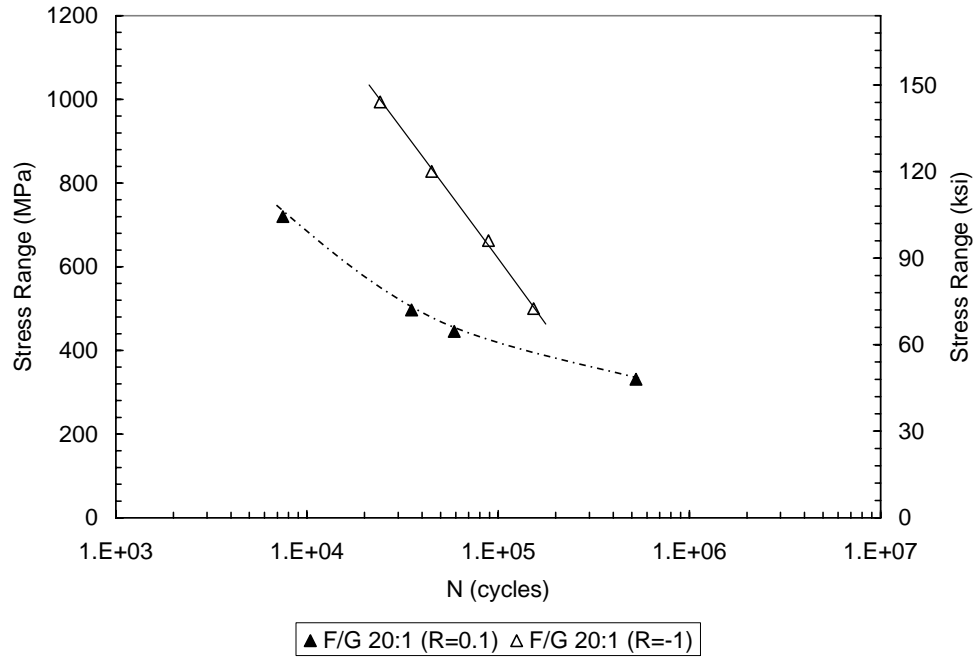
Figure 34: F/G TMC (20:1) TT and TC fatigue results (stress range comparison)

The results are plotted on a stress range basis in Figure 34. Again, the fatigue lives for the tension-compression case are longer than the fatigue lives for the tension-tension case. These results support the observation that the tensile mean stresses present in tension-tension fatigue are detrimental to the fatigue life of the material, while the compressive loading portion is actually beneficial.

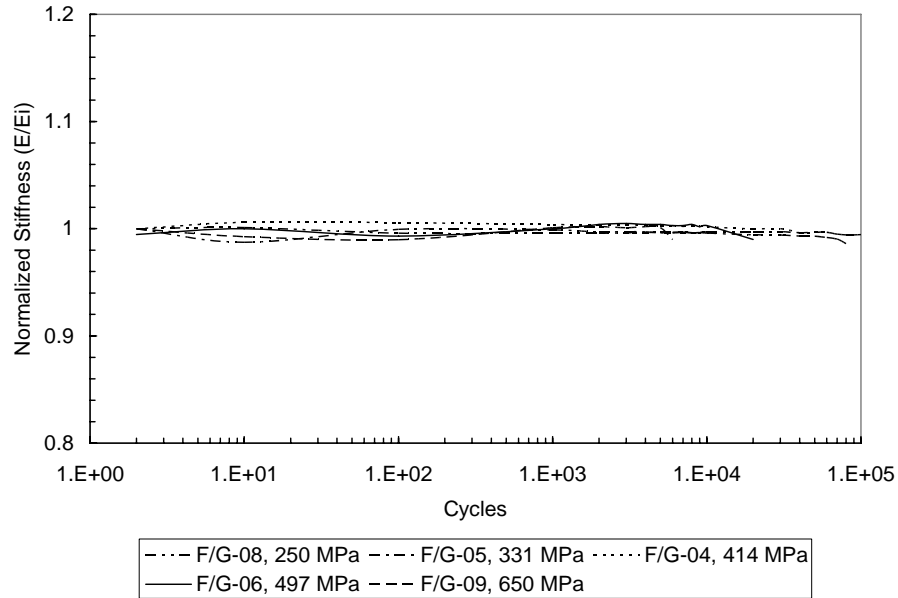
Figure 35: Tension-compression: normalized stiffness vs. fatigue cycles

Again, normalized stiffness and percent strain histories are plotted below for the functionally-graded material. Figure 35 and Figure 36 show plots of the normalized stiffness versus cycle number and normalized fatigue life, while Figure 37 and Figure 38 show plots of the percent strains versus cycle number and normalized fatigue life.

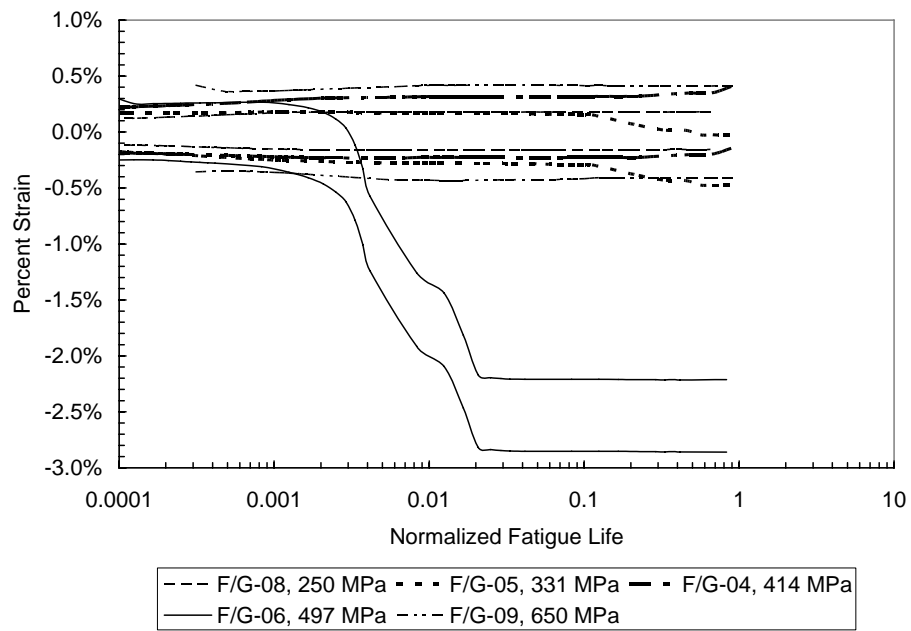
Figure 38: Tension-compression: percent strain vs. normalized fatigue life

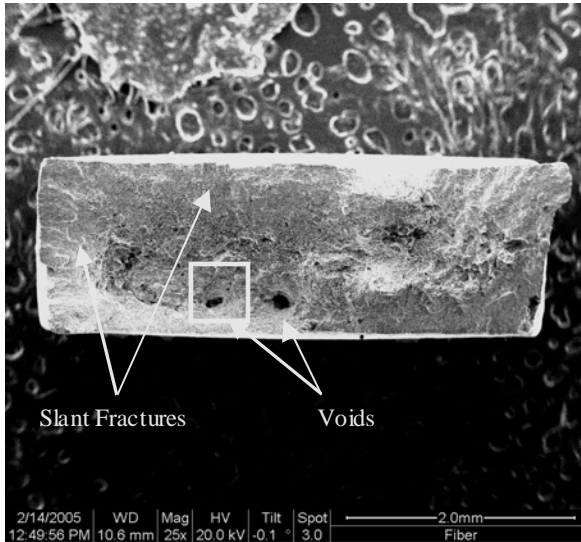
Figure 39: Specimen Ti-001, fracture surface from tensile test

stress [4:92-100]. Normally the stress distribution makes the center of the specimen susceptible to crack initiation. In this case however, the presence of pores in the material may have resulted in the failure shown (see Figure 40).

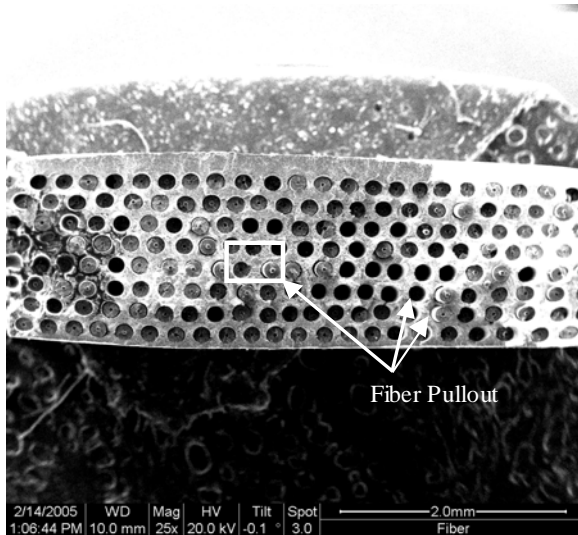
Figure 41: Specimen TMC-001, fracture surface from tensile test

The fracture surface for the composite showed evidence of fiber fracture and fiber pullout (see Figure 41). In order for failure to occur in a unidirectional composite where loading is in a direction parallel to the fibers, all fibers across the cross section must fracture [4:293-305]. The relative contributions of plasticity and damage can be seen in Figure 42. As discussed earlier, pores in the matrix material are prone to form voids representative of a plasticity failure mechanism. As the matrix fails, the load is then transferred to the fibers that ultimately fail either by fiber cracking, debonding or pullout, all of which are representative of damage.

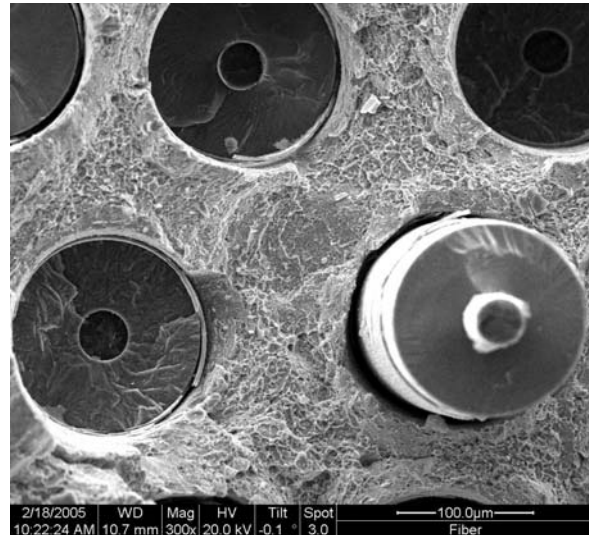
Figure 42: Specimen TMC-001, close-up showing fiber pullout & matrix ductility

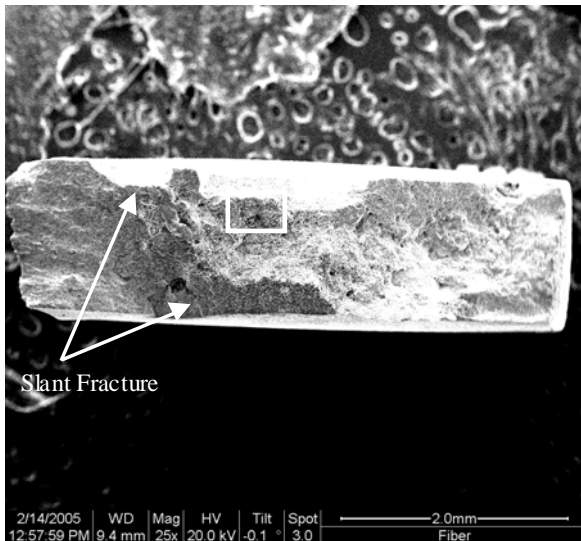
Figure 43: Specimen F/G-001, fracture surface from tensile test

The fracture surface of the functionally-graded material is shown in Figure 43. Since failure occurred in the alloy section, the mechanisms associated with the failure are similar to those discussed for the pure alloy specimen. This time the slant fracture can be seen on both sides of the specimen, indicating initial failure near the center. Again, the rough dimpled surface representative of ductile failure can be seen (see Figure 44).

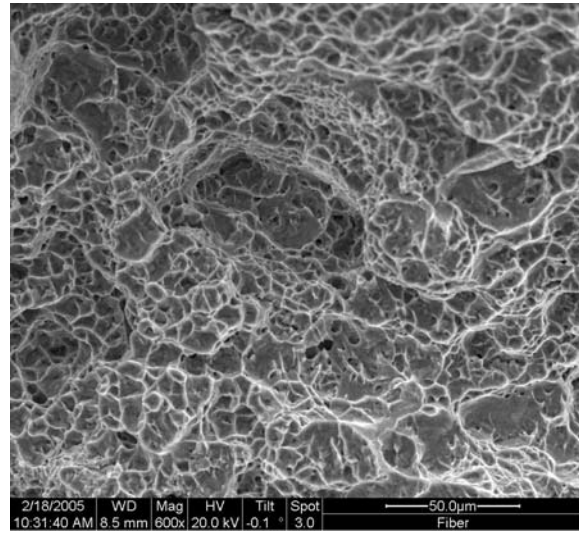
Figure 44: Specimen F/G-001, ductile void coalescence

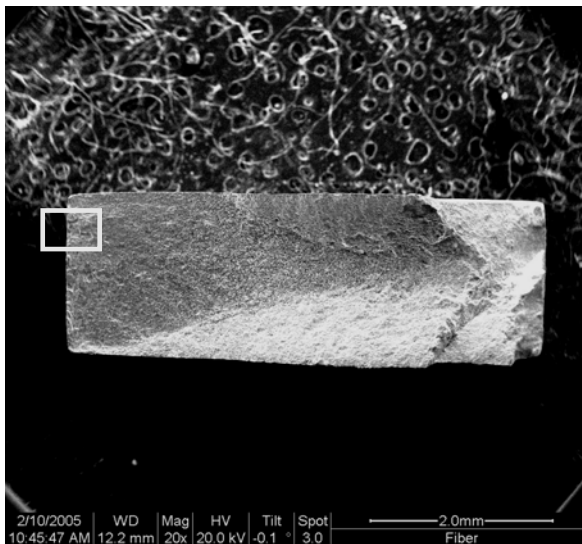
Figure 46: Specimen Ti-03, overall view of fracture surface

Regardless of this fact, the alloy specimens all had similar failure characteristics. From the overall view of the fracture surface, the transition from the fatigue crack propagation region and the final overload region could be distinguished and the point of crack initiation could be narrowed down to the flat, brittle crack face away from the more ductile, overload region (see Figure 46). Upon closer examination of this area, the crack initiation site seemed to be the edge of the specimen where stress raisers are present (see Figure 47).

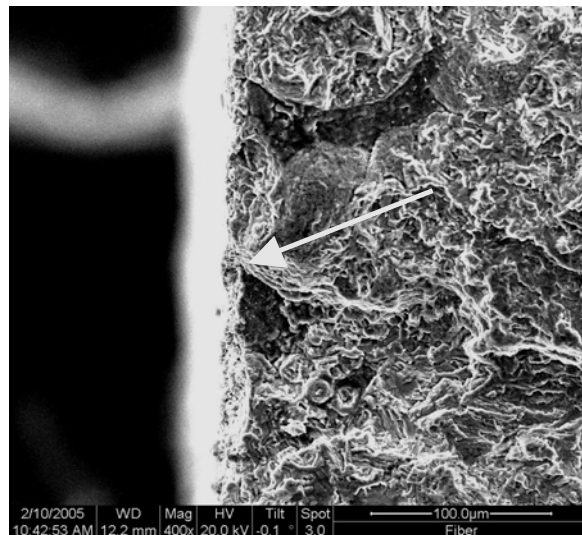
Figure 47: Specimen Ti-03, close-up of crack initiation site

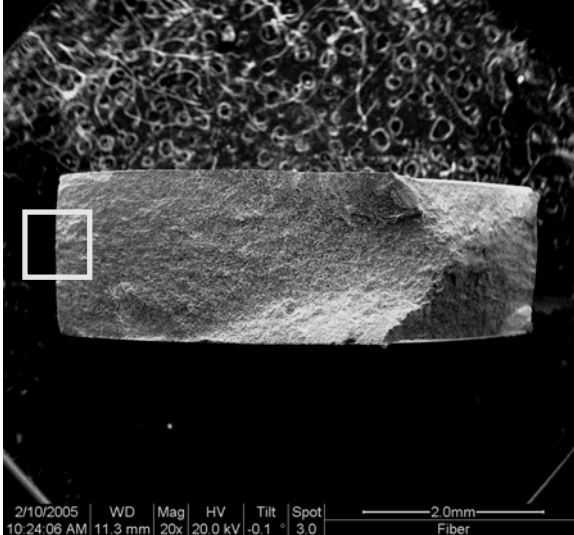
Figure 48: Specimen Ti-01, overall view of fracture surface

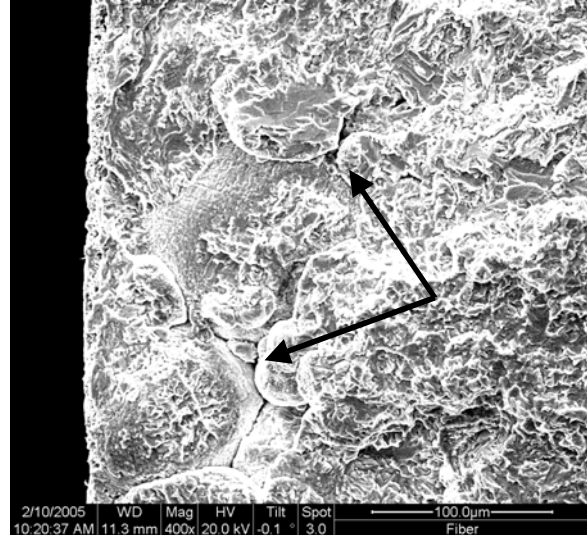
Figure 49: Specimen Ti-01, close-up view of residual pores

examination of the crack center revealed the residual pores in the material (see Figure 49). As mentioned before, all of the alloy specimens that failed under tension-tension fatigue loading exhibited similar characteristics in the failure region. More examples of these types of failures can be found in the appendix.

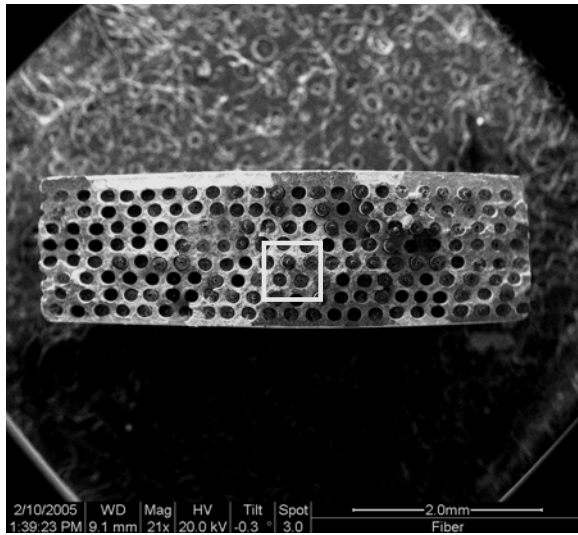
Figure 51: Specimen TMC-10, overall view of fracture surface

When looking at the fracture surface, fiber failure and pullout appear to dominate as damage mechanisms (see Figure 51). At this high stress level, the transition from Region II to Region I on the S-N curve becomes apparent. Upon closer examination of the fracture surface, evidence of ductile void coalescence and necking is observed (see Figure 52).

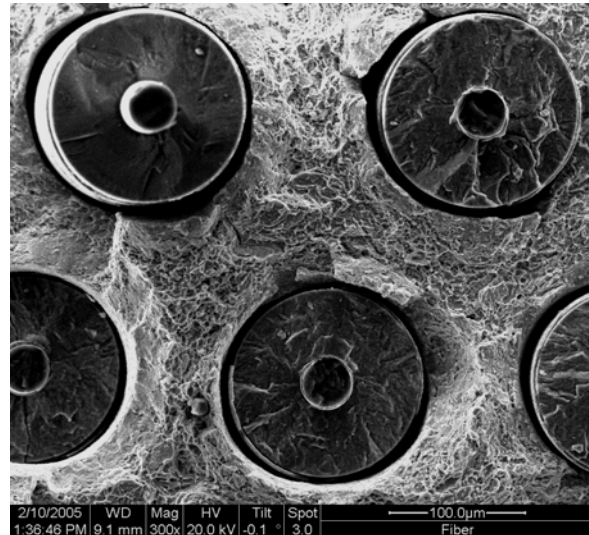
Figure 52: Specimen TMC-10, ductile void coalescence and necking

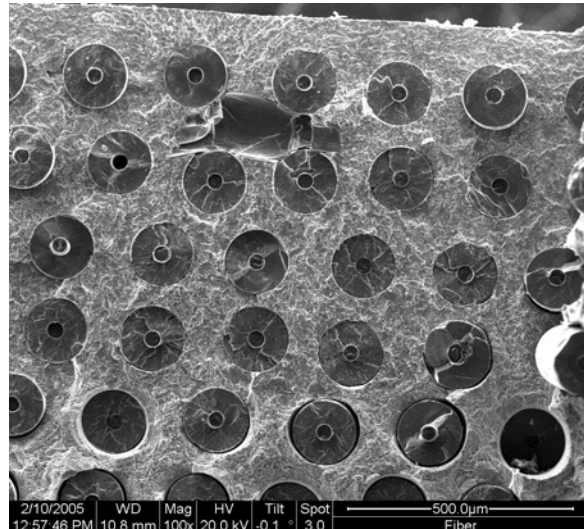
Figure 54: Specimen TMC-03, close-up view of fracture surface

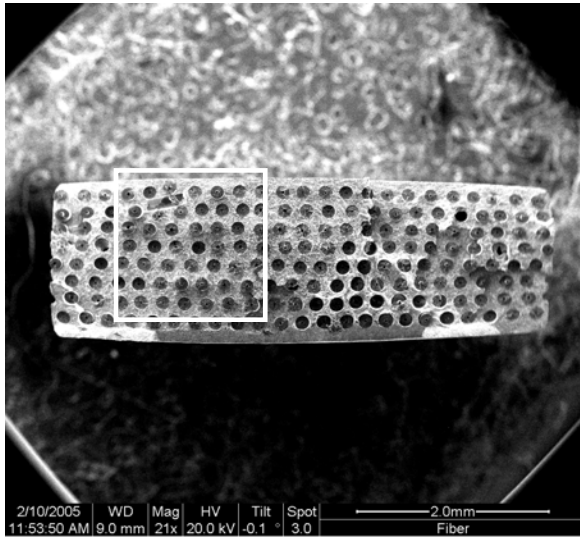
Figure 55: Specimen TMC-01, overall view of fracture surface

As the stress level lowers, less fiber failure and more matrix cracking can be seen (see Figure 55). Upon closer examination of the fracture surface, another fiber shard is observed (see Figure 56). The fiber shard can act as a crack initiator and is usually a sign of poor manufacturing processes. Nevertheless, the results found for this specimen place it also in Region II of the S-N curve.

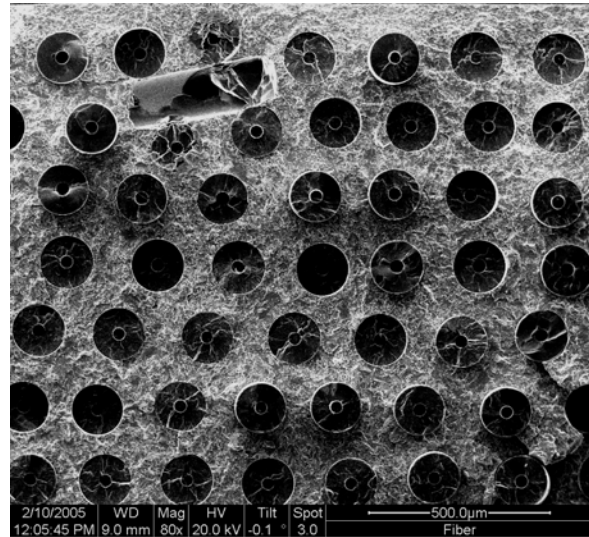
Figure 56: Specimen TMC-01, close-up view of fracture surface

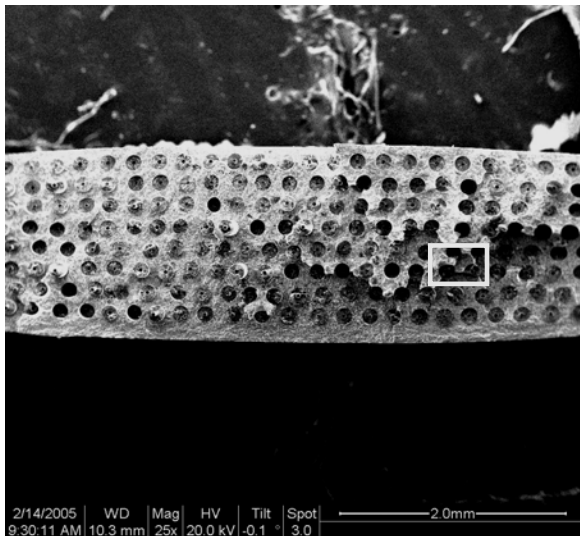
Figure 57: Specimen TMC-11, overall view of fracture surface

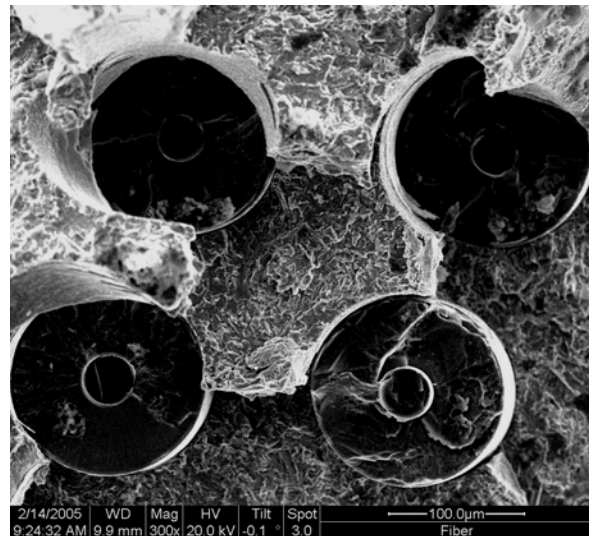
Figure 58: Specimen TMC-11, multiple crack fronts

Again, matrix plasticity as well as some fiber failure can be seen (see Figure 58).

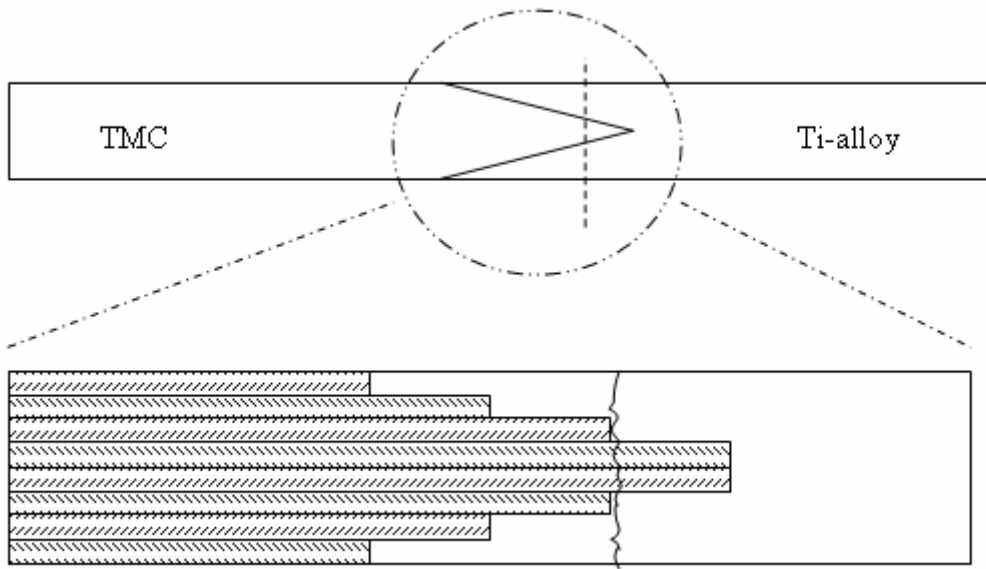
Figure 60: Schematic of failure locations in F/G taper region

While the two specimens that failed in the alloy region simply showed similar microscopic results as the pure alloy specimens mentioned above, the failures in the taper region showed more interesting results as they both failed in the same region of the taper (see Figure 60). A brief discussion of each failure is provided below.

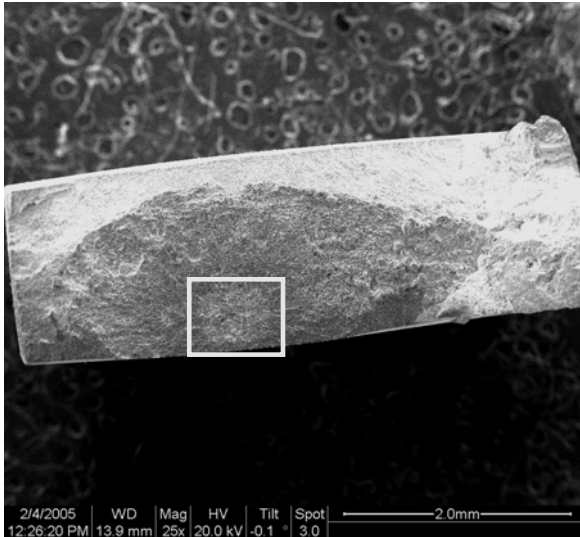
Figure 61: Specimen F/G-10, overall view of fracture surface

Specimen F/G-10: 800 MPa. This highest stress level test failed after only 7,470 cycles and failed in the alloy section of the specimen. Examination of the sectioned specimen revealed similar findings as the pure alloy specimens. The final overload fracture associated with stage III crack propagation is clearly seen (see Figure 61). Following away from this area, the striations associated with stage II crack propagation lead to the point of crack initiation (see Figure 62). The matrix flaw at the crack initiation site is similar to those found in the pure alloy specimens. This is as expected since failure in the alloy region only serves to provide information about the alloy section itself.

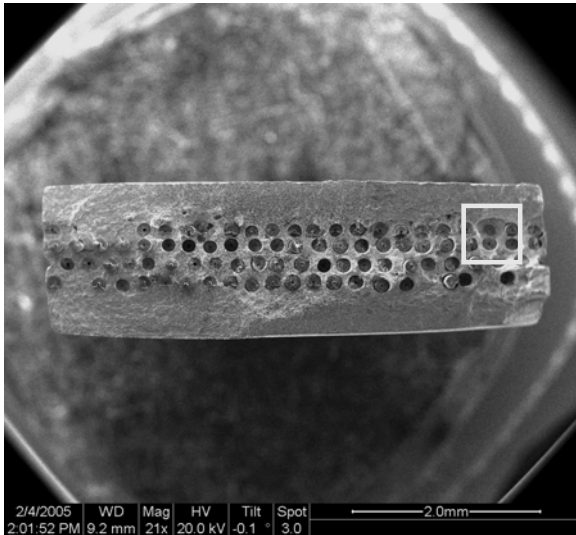
Figure 64: Specimen F/G-03, fracture surface (looking toward composite side)

to the next step. The existence of four plies is readily seen (see Figure 64). Looking toward the pure composite end of the specimen, it is apparent that the areas of “missing fibers” along the upper and lower plies represent the higher “peaks” of the fracture surface. Upon closer examination, it was determined that the fiber ends were the points of crack initiation as deposits of the matrix material still existed on some of the fibers (see Figure 65). In this figure, the upper two fibers both show smooth textures characteristic of a fiber end, while the lower two fibers both show signs of fracture by their rough textures.

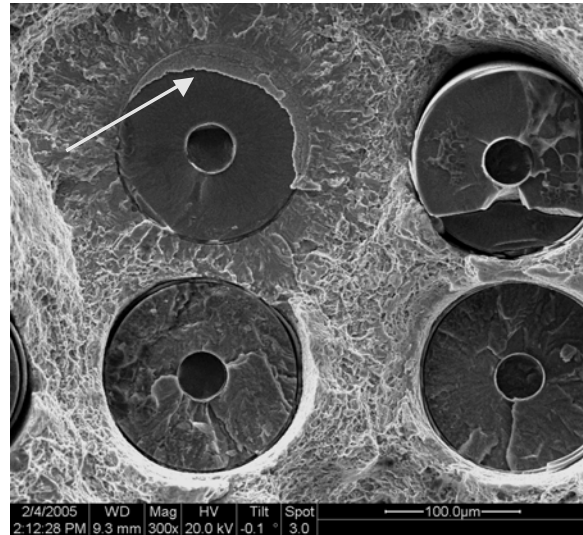
Figure 65: Specimen F/G-03, matrix material on smooth fiber end

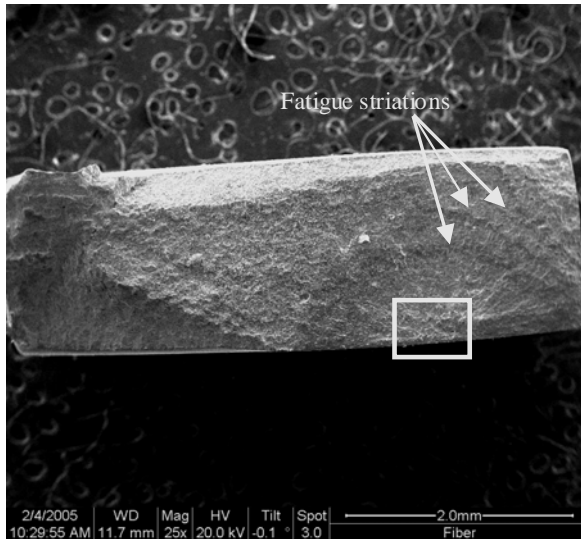
Figure 66: Specimen F/G-01, overall view of fracture surface

Specimen F/G-01: 495 MPa. This specimen failed after 58,872 cycles and failure occurred in the alloy region. Examination of the sectioned specimen revealed residual pores as the cause of crack initiation (see Figure 66 and Figure 67). Just as in the pure alloy specimens, the residual pores become centers for crack initiation. Again, failures in the alloy region will exhibit characteristics similar to the pure alloy specimens.

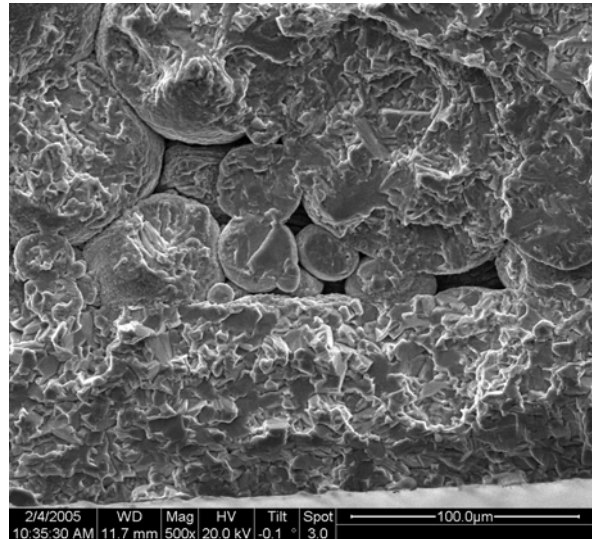
Figure 67: Specimen F/G-01, close-up view of residual pores

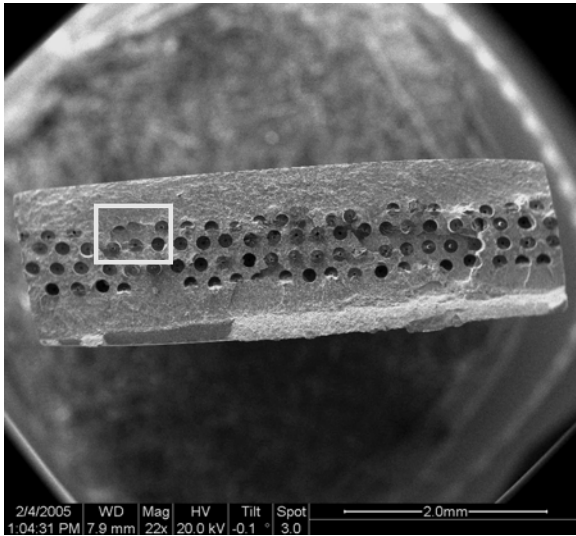
Figure 69: Specimen F/G-02, fracture surface (looking toward composite side)

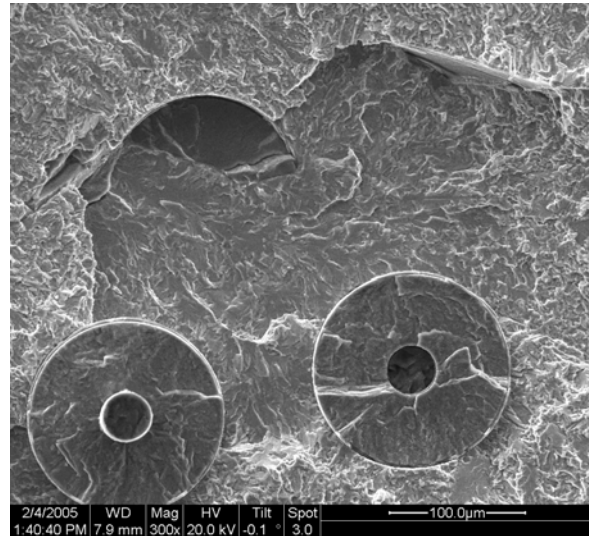
Figure 70: Specimen F/G-02, matrix material on fiber end

these areas showed deposits of the matrix material on some of the fibers (see Figure 70). The lower two fractured fibers can again be distinguished by their rough appearance, while over half of the upper fiber is covered by matrix material.

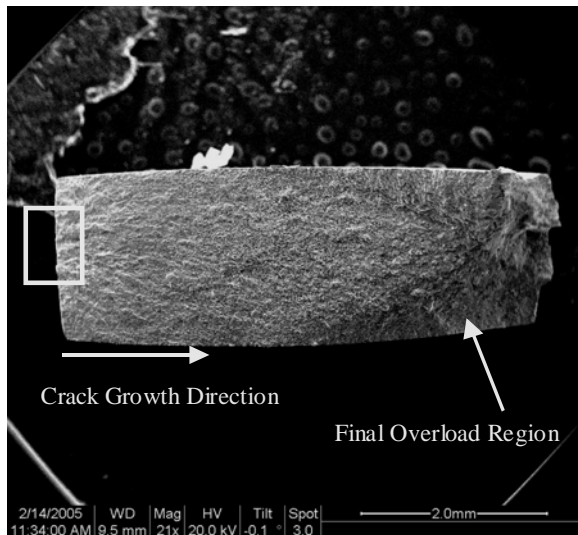
Figure 72: Specimen Ti-08, overall view of fracture surface

As before in the tension-tension case, the alloy specimens all had similar failure characteristics. The transition from the fatigue crack propagation region and the final overload region could again be distinguished from the overall view and the point of crack initiation could be found (see Figure 72). Just as in the tension-tension case, the crack initiation site seemed to be the edge of the specimen where stress raisers are present (see Figure 73).

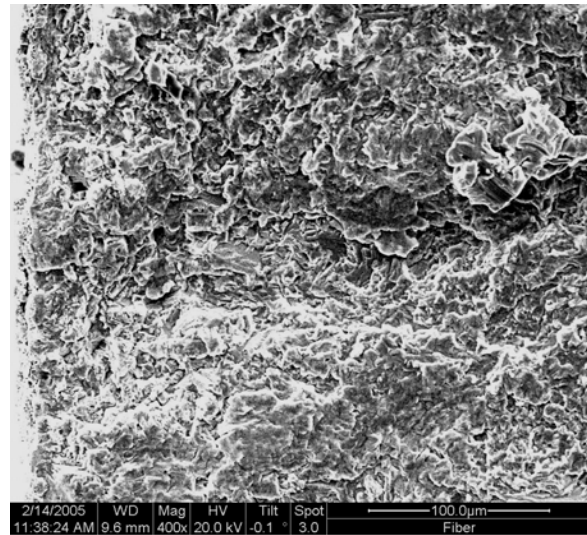
Figure 73: Specimen Ti-08, close-up of crack initiation site

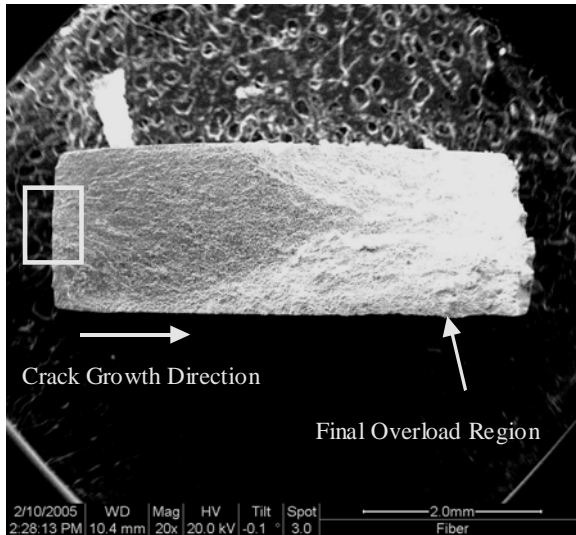
Figure 74: Specimen Ti-06, overall view of fracture surface

Notice also the shortening of the fatigue crack propagation region and the respective lengthening of the final overload region when the stress level is increased. Even with this relatively small increase in stress level, the difference is clearly seen. Although residual pores can be observed as crack initiators, none of the specimens tested in tension-compression showed this phenomenon. Instead, all failures seemed to occur at stress raisers at the edge of the specimens. More examples of these types of failures can be viewed in the appendix.

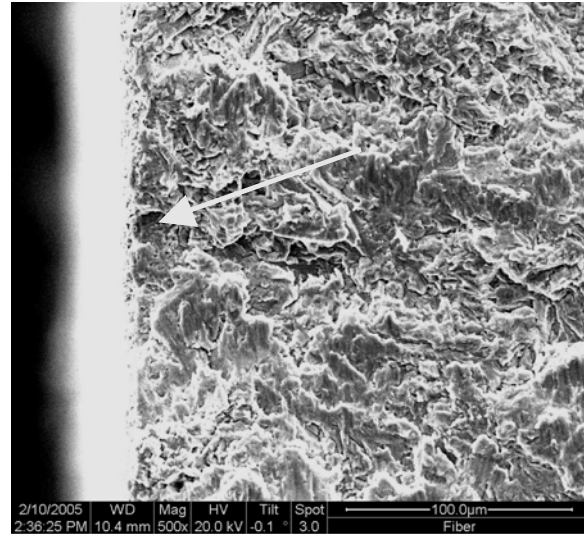
Figure 75: Specimen Ti-06, close-up view of crack initiation site
